# SAFETY INVESTIGATION REPORT

REPORT NO.: 03/2013

***MV KADRI***  
**Fatality of Crew Member and**  
**Serious Injury of another Crew Member**  
**in position 58°13.8'N 021°15.9'E**  
**11 March 2012**

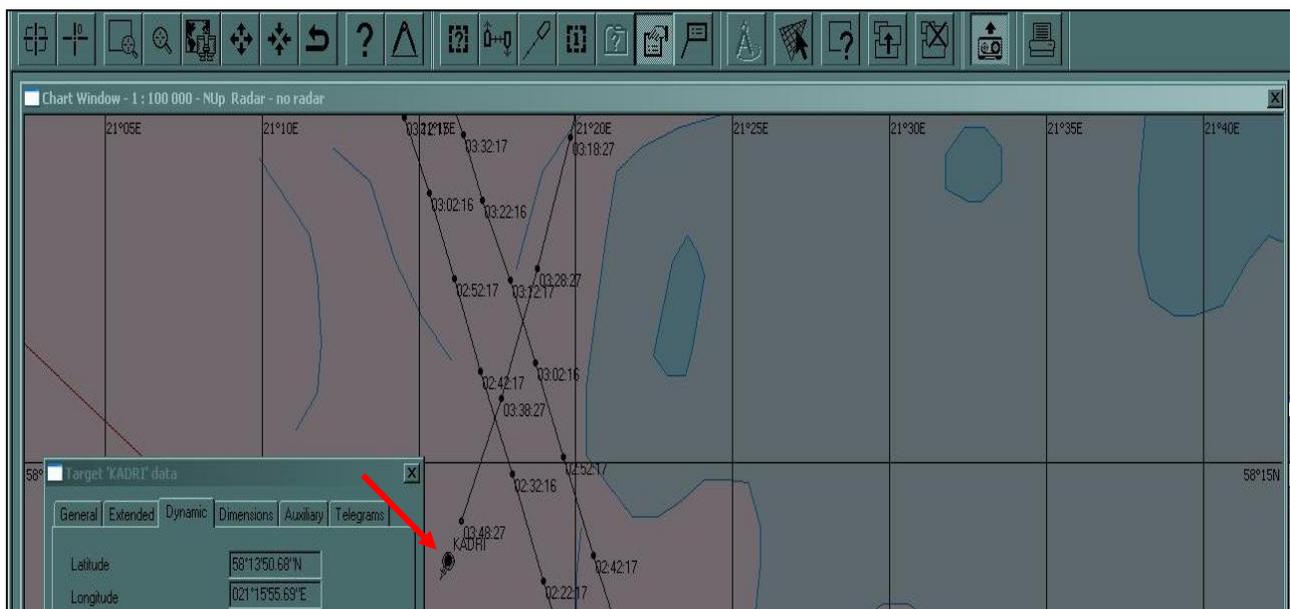
Figure 1: *Kadri*'s AIS track indicating her geographical position at the time of the accident

Between 0000 and 0100, the weather was moderate. However, at about 0200, *Kadri* started experiencing heavy swell and strong wind gusts. Until the time of the accident, the vessel continued to maintain her course (Figure 1), although she was continuously sheering due to the wind. This necessitated the second mate to correct the course by several degrees.

The documentary evidence provided by the coastal State (Figure 1) indicated that no attempts to alter course were made in order to reduce the ship's heavy movements. It was therefore evident that the Company Procedures Manual (Safe Navigation), namely Chapter 3, section 3.8 – Heavy weather conditions, regarding adverse weather were not followed<sup>1</sup>.

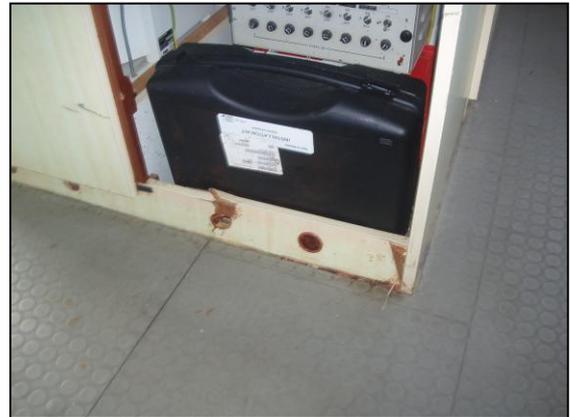
At this point, the second mate received his serious injuries. Overcome by the vessel's accelerating forces, he could not see the chief engineer. The damages to the bridge furniture were considerable and commensurate to violent accelerations of the ship (Figures 2 – 4).

**Figure 2: Damaged bridge furniture**

**03/2013\_R2** Conduct a risk assessment in order to identify and mitigate risks associated with fittings / loose furniture on board.

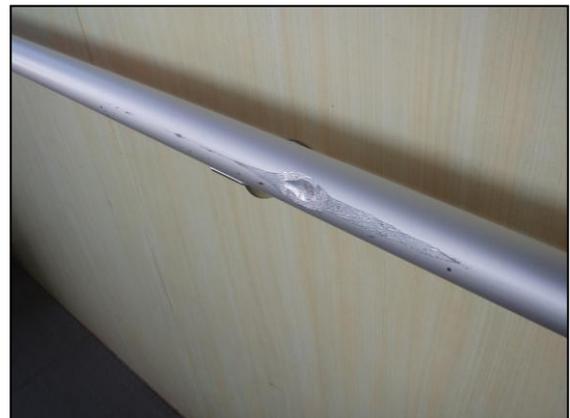
**Figure 3: Dented hand rail**

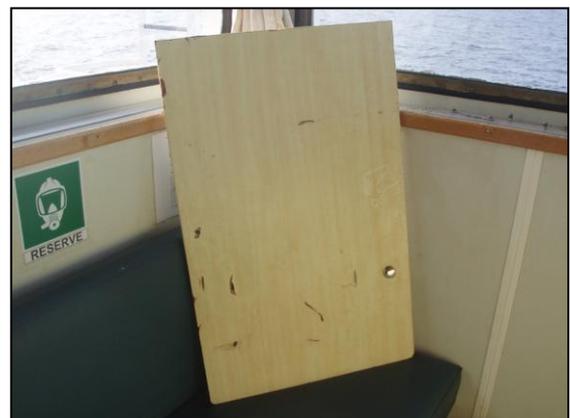
**Figure 4: Damaged cabinet doors**

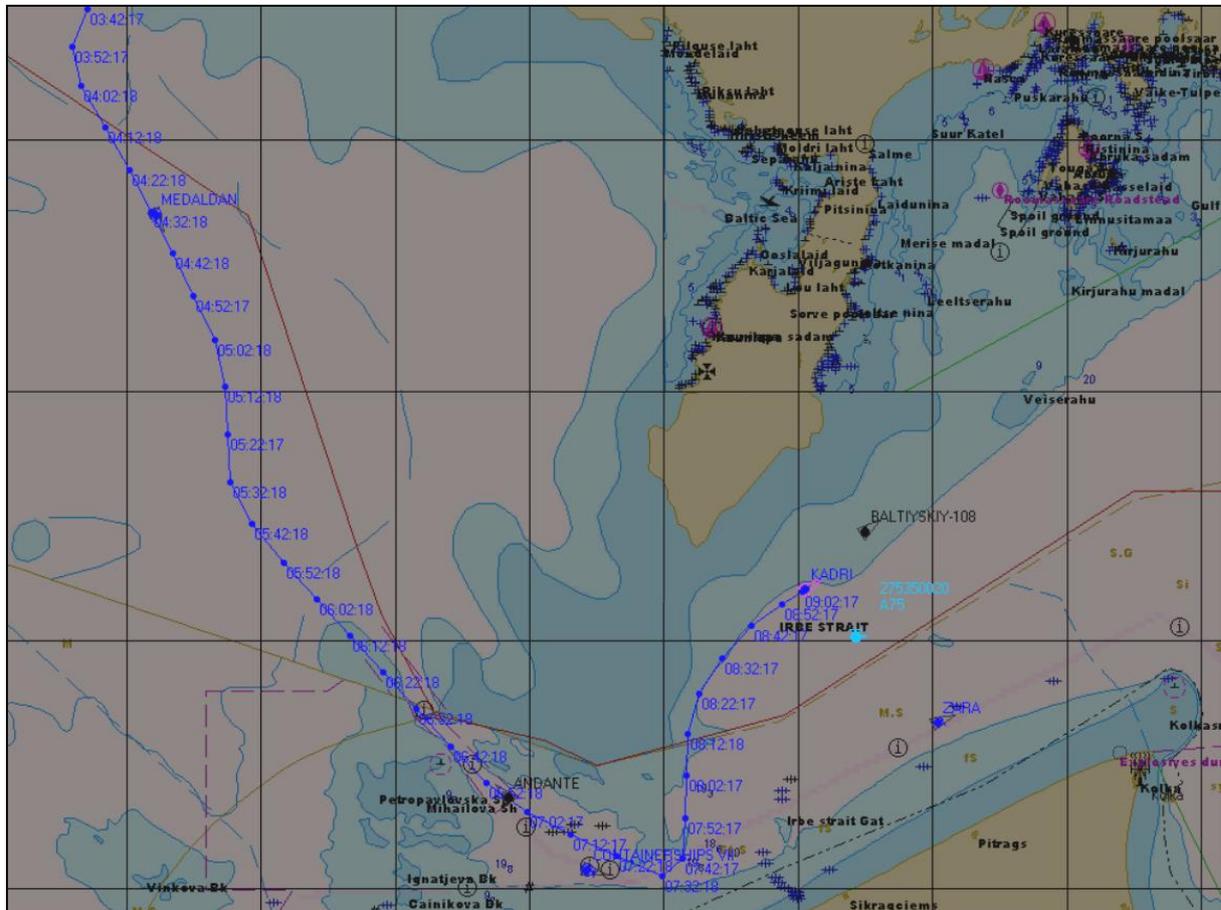
Figure 5: *Kadri*'s alteration of course in preparation for the MEDEVAC

The master called Ventspils Port Control for assistance, but was told that the port was closed because of the stormy weather. He then called Latvia Coast Guard and after being granted the necessary authorisation, *Kadri* altered course (Figure 5) for a possible evacuation (MEDEVAC). Later on, the master was able to consult a medical doctor by radio, and received further medical instructions.

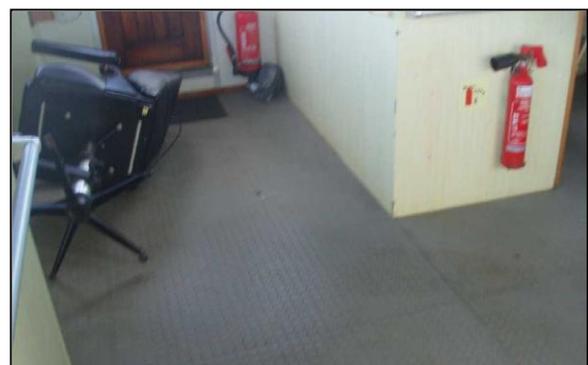
**Figure 6: Kadri's bridge pilot chair following the accident**

One of the photographs taken after the accident showed that the type of chair used on the bridge was not appropriate, in that it was unsecured and with roller wheels (Figure 6).

This resulted in the chair being flung in an uncontrolled manner across the bridge deck, when the vessel pitched and rolled violently. It was not excluded that this

could have worsened the injuries of both crew members.

5. The design/style of the chair was not adequate for shipboard use. Rather than specifically strengthened and secured to the deck, the design/style of the chair was inadequate for shipboard use.
