**PRELIMINARY REPORT
AIRCRAFT ACCIDENT INVESTIGATION COMMISSION**

**Aircraft Accident involving helicopter Sikorsky S76 C+
Registration mark OH – HCI**

Tallinn Bay, 10 August 2005

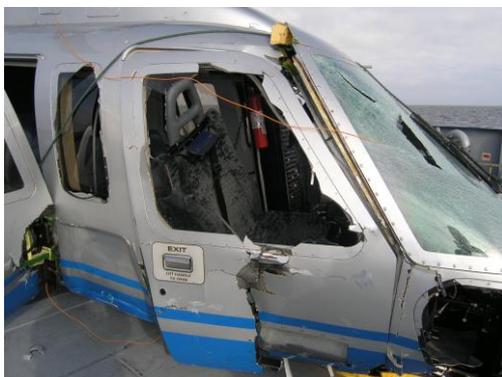
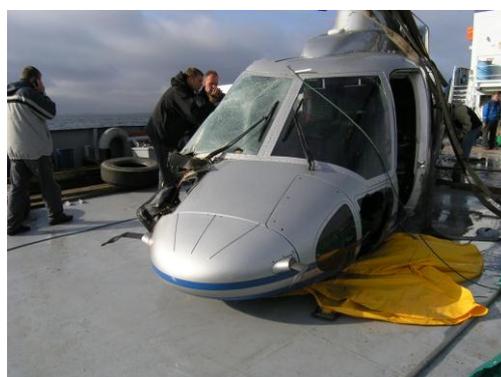
Right windshield of the helicopter was damaged and heavily cracked, but had practically retained its form and was fixed in its place. Right-hand cockpit door`s window was

destroyed,

the pieces of the central part of the organic window class could not be found. Both downward vision windows situating at pilots` feet were destroyed. Right cockpit door was closed, but heavily deformed and the airframe surrounding the door was also heavily deformed.

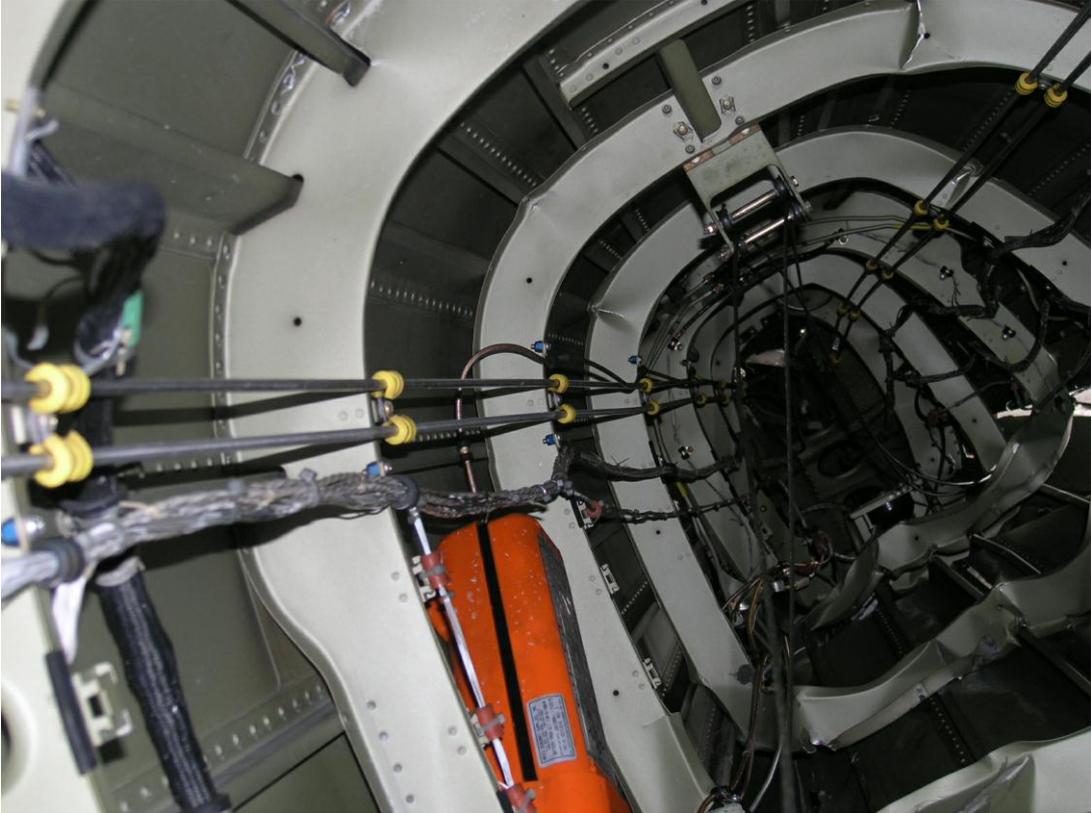
Emergency Locator Transmitter (ELT) of the helicopter was at its place on helicopter's tail and its switch was in the "off" position.

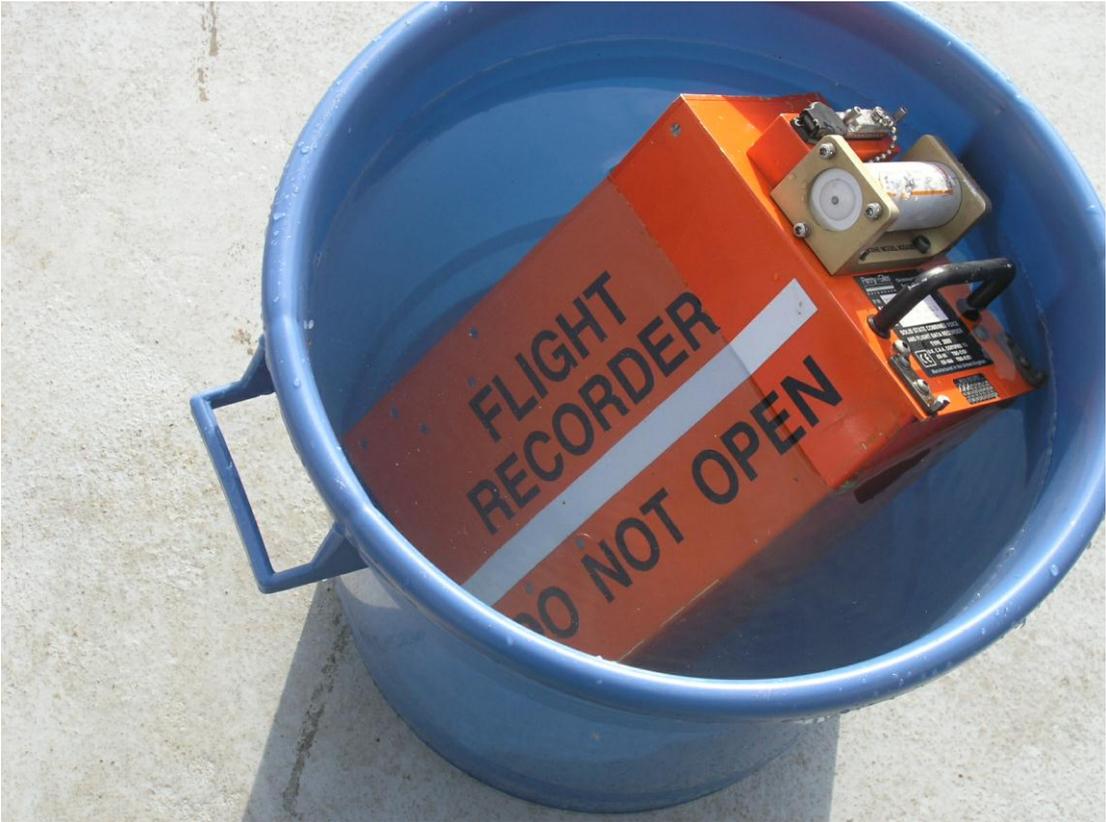
Helicopter's flight recorder was not damaged and it was removed from the helicopter.

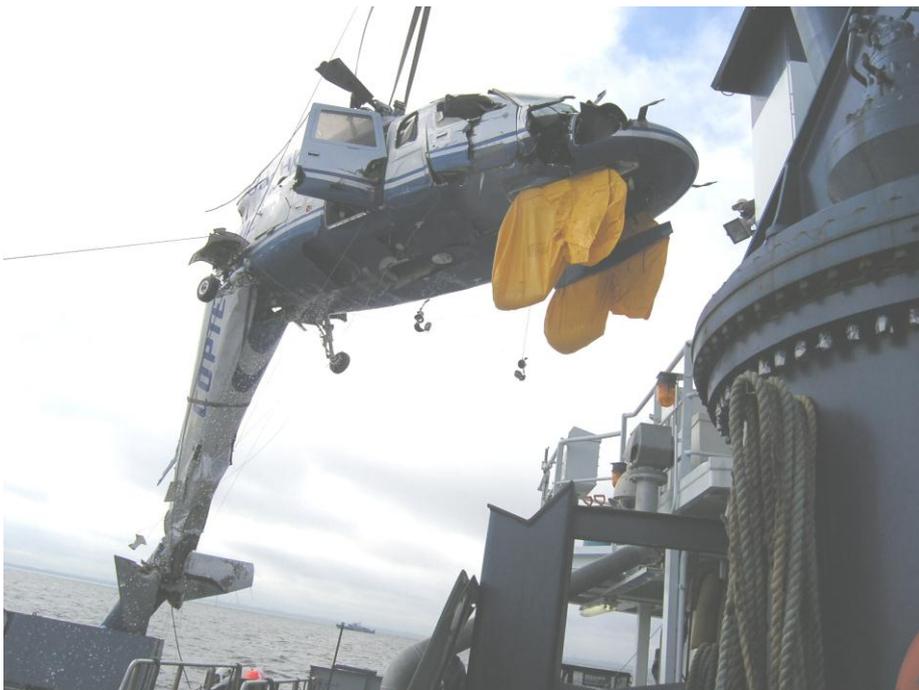
Helicopter main rotor hub was complete, it had the root ends of four main rotor blades attached to it, every one of different length (from 30 cm to 1 m).

Both engines of the helicopter, their cowlings and their main output shafts were undamaged.

Left fuel tank of the helicopter was intact, the right one was damaged.
